PHOTOGRAPHIC INTERPRETATION REPORT

CHANGES AT
SUSPECT AMM PHASED-ARRAY RADAR
NARO-FOMINSK, USSR
FEBRUARY-APRIL 1964

NPIC/R-438/64 June 1964

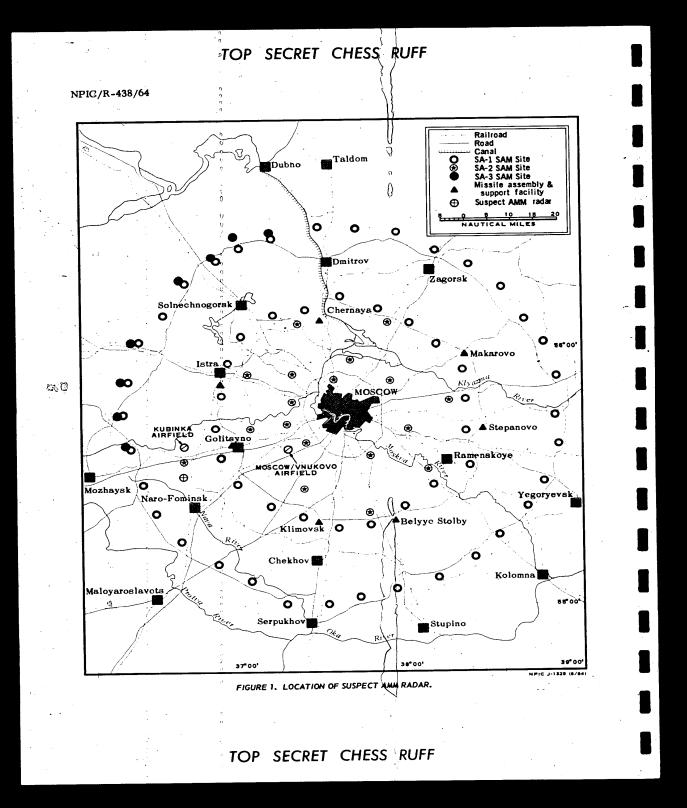
Photography provided the first large-scale, KH-7 coverage of the suspect AMM phased-array radar at 55-29-50N 36-41-10E, 7 nautical miles (nm) north-northwest of Naro-Fominsk and 35.7 nm west-southwest of Moscow (Figure 1). This photography (Figure

2) permits a more detailed description of the suspect phased-array radar and the construction status of the installation than previously published. 1/ A description of changes observed since February follows.

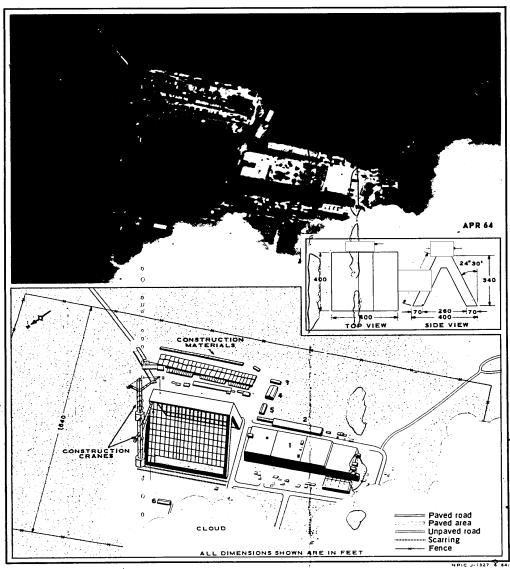
FIGURE 3. OPERATIONAL AREA A.

Operational Area A. Monocular coverage obtained from of of the suspect phased-array radar shows that construction of the facility is continuing (Figure 3). A large quantity of construction material is stored in the open throughout the area, the largest quantity being stored in the clearing south of the suspect radar. On photography of February 1964, there appeared to be a snow-covered low earthen wall at the extreme south edge of the cleared area, but April photography shows this to be open storage of construction material. It appears that additional material has been brought into the area since February.

The inverted V-shaped structure measures 340 (320) feet high, 400 (390) feet across the base, and tapers to (95) feet at the top (Figure 3). The possible ramp reported on the top of the structure is not visible, and the top now appears as a solid, flat rectangular platform. The sides

of the structure appear 70 (65) feet thick. The two faces of the structure are each 400 (325) feet wide with a slant height of (350) feet at an

The north-northwest face is composed of 18 probable steel girders (excluding the two terminal girders) evenly spaced 20 feet apart and at a 30 minutes to the base. Shadows indicate a similar type of construction on the opposite face of the structure. The open appearance of both faces contrasts sharply with the apparently solid faces seen on February KH-4 photography. The solid-face appearance probably was created by a temporary environmental covering that has been removed with the arrival of favorable weather. Across the base of the north-northwest face, approximately 345 feet of solid light-toned facing material has been positioned on the perpendicular members, indicating that horizontal girders probably are present although not discernible on the coverage of April 1964. A short distance north of this face there are two parallel ground scars that extend the entire width of the structure. This scarring was not visible in the snow in February. On the east side of the structure are two tower cranes ap-

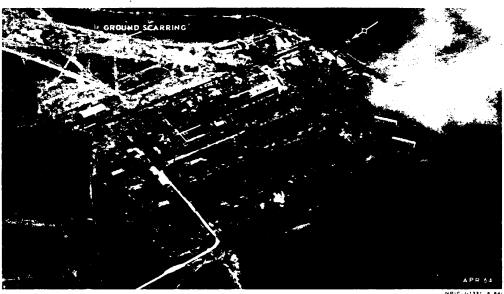
FIGURE 7. TRANSFORMER SUBSTATION UNDER CONSTRUCTION.

A major (500 kilovolt) transformer substation is under construction approximately 1.75 nm (11,700 feet) west of the suspect radar. When completed it probably will furnish power for the installation. On April photography there is no

evidence of overhead lines, but there is some indication of ground scarring extending from the substation toward the suspect radar, possibly indicating a buried conduit (Figure 7).
